ELECTRO-MOTIVE DIVISION • GENERAL MOTORS CORPORATION

# MAINTENANCE INSTRUCTION

## MODERNIZATION RECOMMENDATION AUXILIARY GENERATOR DRIVE SHAFT GUARD – GP38, SD38

APPLICATION: All GP38 and SD38 locomotives built prior to January 1, 1971.

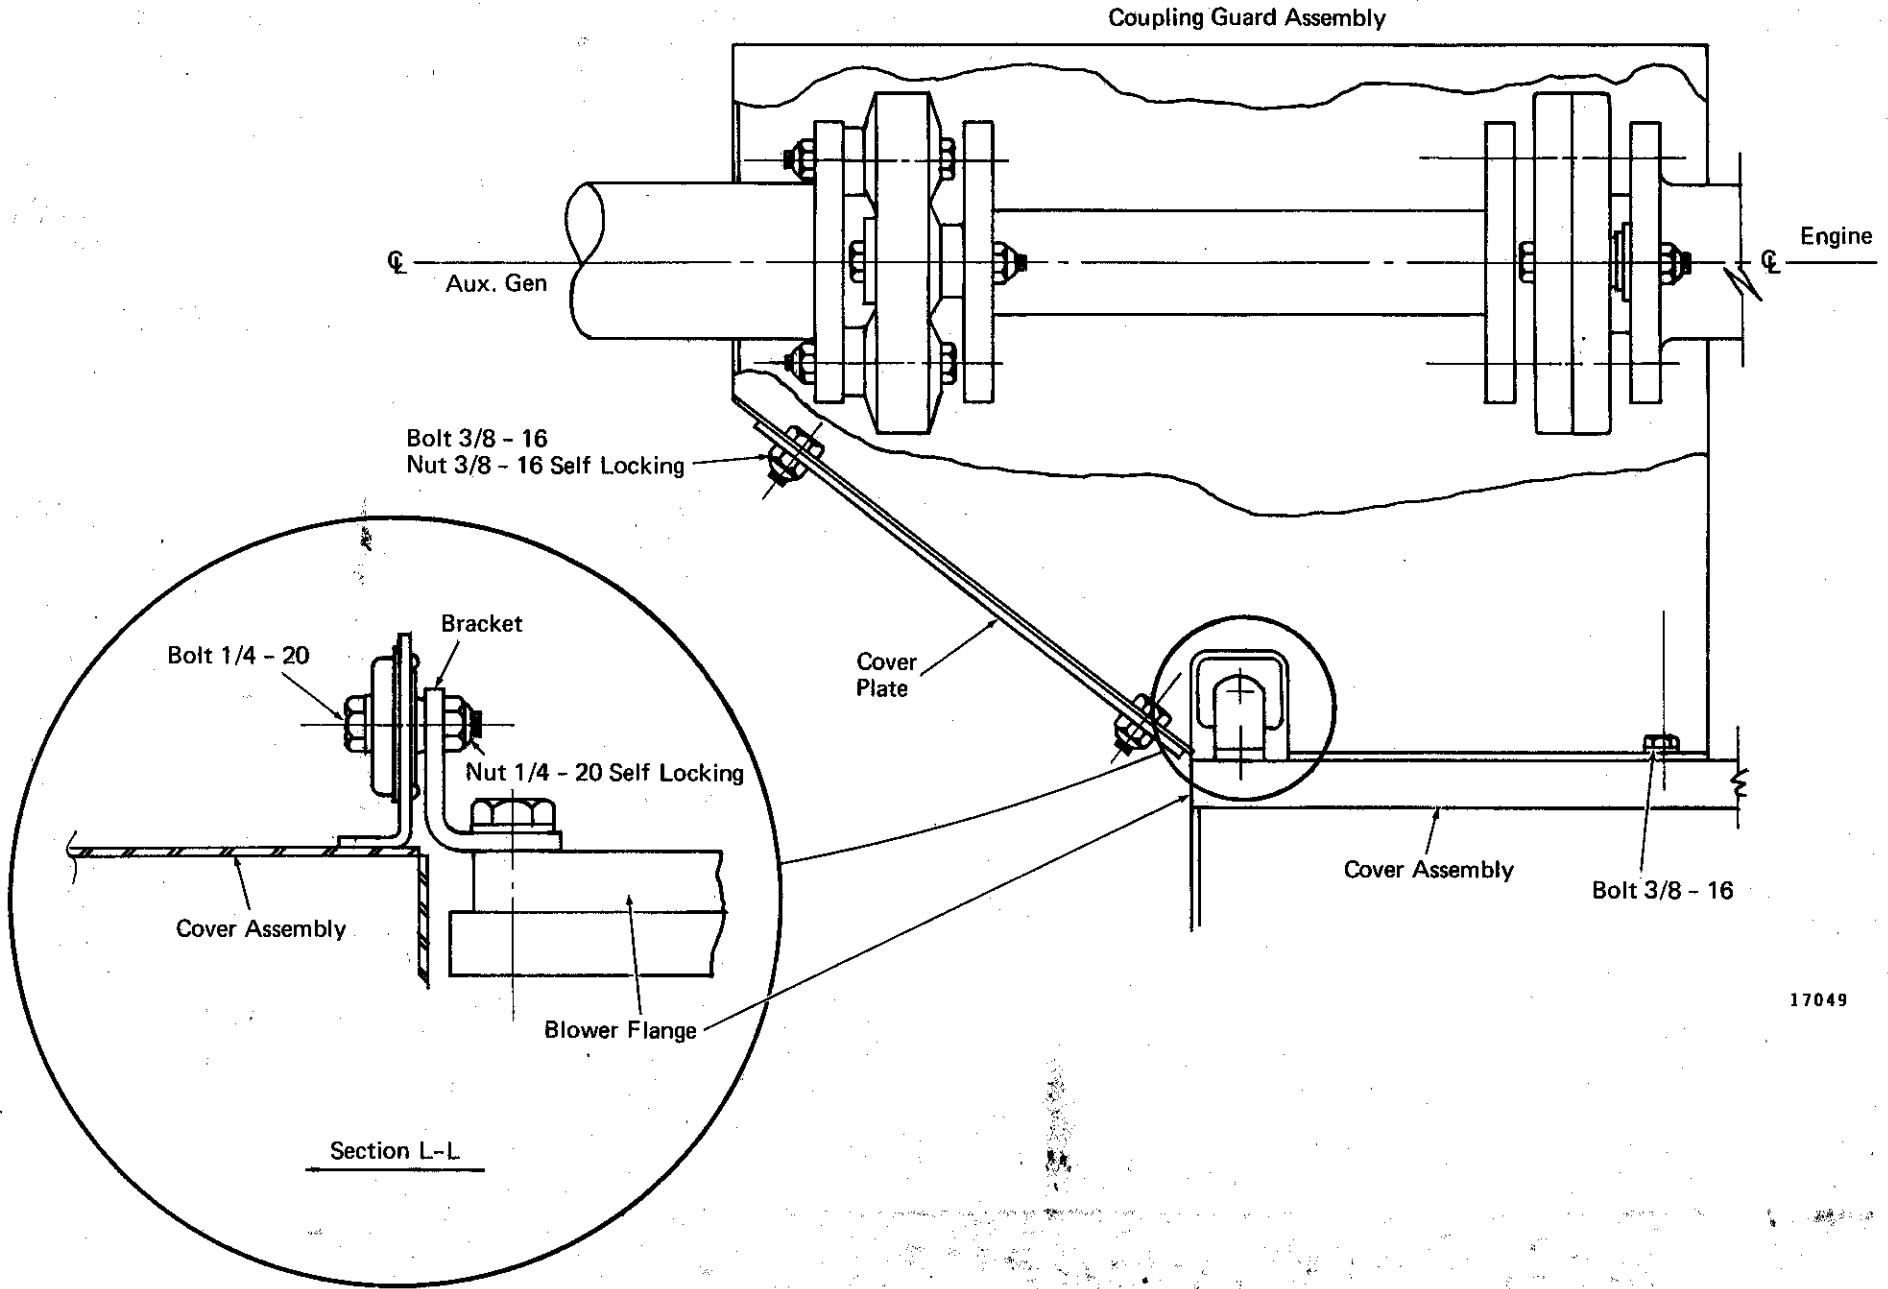
Fig. 1 - Application Of Shaft Guard

PURPOSE: This instruction describes an improved auxiliary generator drive shaft guard which will assure greater reliability and safety.

1. Remove original bracket assembly 8413370 and guard assembly 8434345.
2. Apply new material per reference drawing 8449443, Rev. A and Fig. 1.
