# MAINTENANCE INSTRUCTION

## MODERNIZATION RECOMMENDATION

### EXHAUST SCREEN INSPECTION PORT FOR REAR EXHAUST MANIFOLD

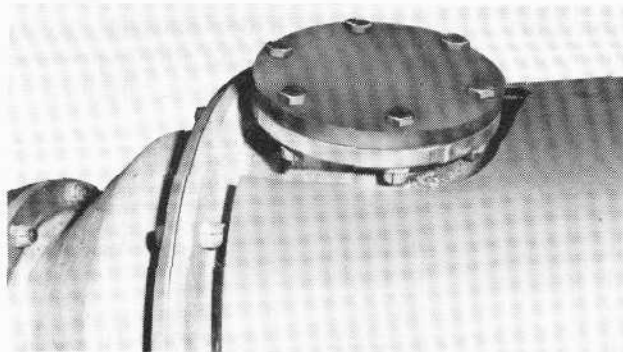
Fig.1 - Exhaust Screen Inspection Port

- DISCUSSION:** The exhaust screen inspection port for the rear exhaust manifold is now available as kit 9336983. This inspection port has a 4" diameter access opening to view the exhaust screen plate. This will allow the customer to inspect the exhaust screen without physically removing the screen from the manifold.

1. Remove rear exhaust manifold from the engine.
2. Cut 4-5/8" diameter hole in the exhaust chamber as shown in 9336983.
3. Clean surface prior to welding by wire brushing any foreign substance. Remove all oily deposits with commercial solvent.
4. Insert flange tube assembly 9316671 so that the tube penetrates the outer body approximately 3/16" and in the orientation and location as shown in 9336983. Tack weld in place.
5. Weld the tube with the special 8018-B2 welding rod supplied as item No. 6 of the kit. A continuous 3/16" fillet weld (no voids) is required on the inside and outside.

6. Assemble per 9336983 torque all six bolts to 80 ft-lbs.
7. A modified heat shield assembly 9320186 should be used or the original heat shield altered by cutting a 7-1/4" by 6-13/16" slot as shown in 9320184 and 9320185.
8. Remove all welding slag and foreign material from the interior of the assembly. Shot blasting is permissible if all potential shot traps are shielded and the chamber is thoroughly inspected prior to application.
