Pointers

1980 INVENTORY

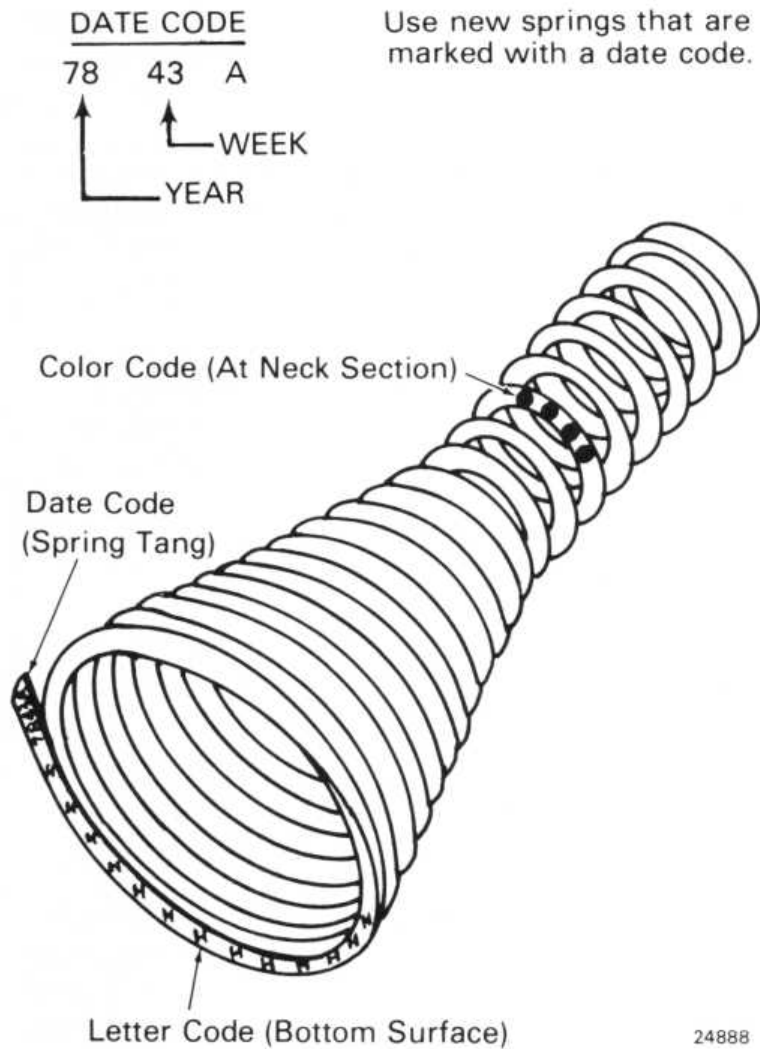
Fig.1 - Date Coded Speeder Spring

All PGR speeder springs manufactured since November 1978 have an improved cycle life and have been marked with a date code for identification purposes, Fig. 1.

At the time of governor overhaul, replace any speeder spring marked with the letter code "H" or color coded "BLUE-RED-RED-RED" that does not have a date code.

Also replace any springs having a date code of 9 years prior to time of overhaul. When the speeder spring is replaced in a governor, stamp governor nameplate in the upper right-hand corner with the letters TC and the year of the replacement; for example, if the spring was replaced during the year 1980, the nameplate should be stamped TC80.

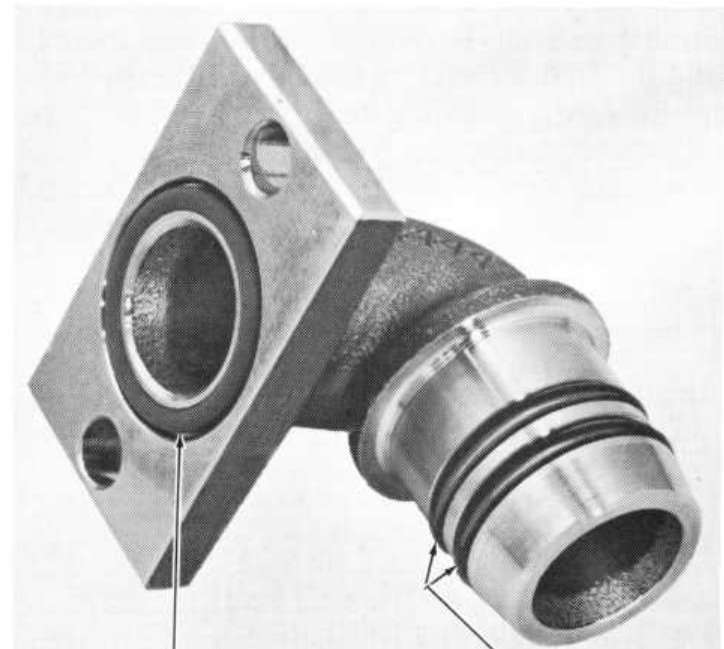
Fig.2 - Water Outlet Elbow Seals

Double-groove discharge elbows, Fig. 2, were first introduced on 645 engines in January 1969. Prior to that time, single-groove elbows were standard on most 567 engines and some early 645 engines. Only Model 567E and all 645 engine crankcases have the necessary top deck thickness to accept the double-groove elbow, and should be so equipped to take full advantage of the improved sealing qualities of the Viton O-rings.

Investigations have found that some reported discharge elbow seal leaks were caused by improper application of power assembly crabs and maintenance of crab nuts at a low torque value. This allowed "working" of power assembly in crankcase which resulted in accelerated elbow and O-ring seal wear. All new, replaced, or in service power assemblies should have crab nut tightness checked and retorqued at intervals specified in the applicable Scheduled Maintenance Program.

Before installing discharge elbows with the new O-rings in a used crankcase, the water inlet holes in the case must be carefully cleaned to remove scale and corrosion. A bottle type wire brush tool and a slow speed air or electric drill are recommended for this purpose. As an alternate method, a hand operated 1.438" ± .0005" reamer may be used. However, expansion reamers, hones, or other such uncontrolled material removal devices should not be used as they will oversize the holes. Correct hole sizing is required to ensure the proper compressive fit of the O-ring seals in the discharge elbow grooves to prevent water leaks.

When the water inlet hole is smooth and clean of chatter marks, check for an oversize or out-of-round condition by measuring the bore at three positions in 2:00 o'clock increments, both at 1/2"

below top of hole (top deck side) and 1/4" above bottom of hole. Standard bore size is 1.438" ± .002" with a condemning limit of 1.450". Holes found to be at or beyond this limit will require weld build-up and remachining back to size.

Apply a light coat of EMD recommended silicone grease on the new O-rings to protect and retain them in the discharge elbow grooves during installation of cylinder head or power assembly in the crankcase.
