GM Locomotive Group

LOCOMOTIVE POINTERS

3L-89 Edition, September 1989

Document Number MM000009

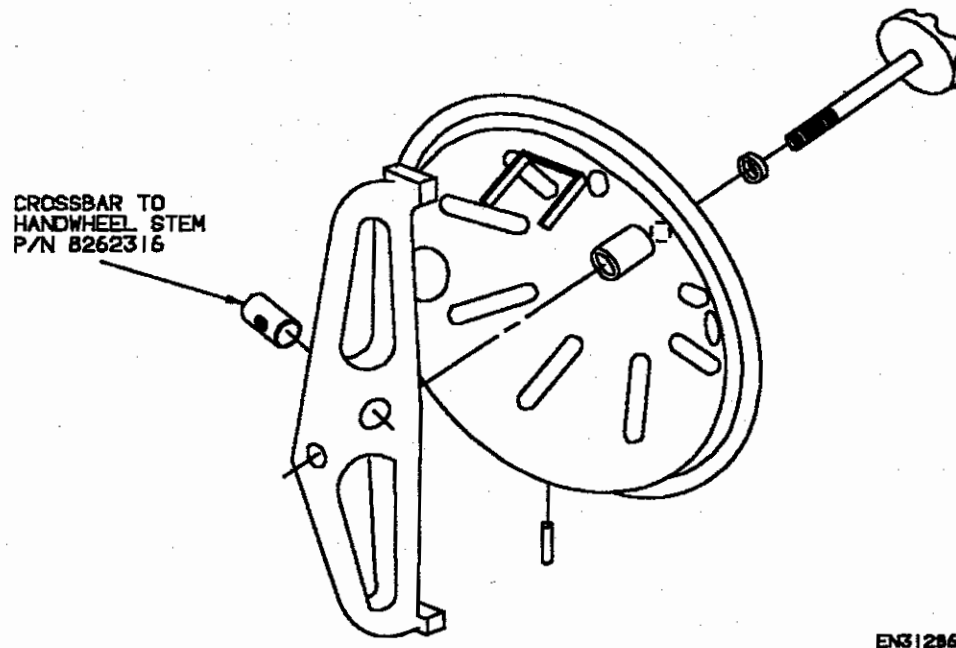
Figure 1. Handhole Cover Assembly

Due to an inconsistency in tapping of threads in handhole cover crossbar to handwheel stem pin 8262316, Figure 1, EMD recommends that all handhole covers made since 1986 be inspected at a scheduled routine inspection.

The subject pins may have been tapped on a angle which is not perpendicular to the axis of the pin resulting in a bending fatigue in the handwheel stem when applied to the air box. Under these conditions, the stem is subject to a fatigue fracture and, due to the high air box pressure exerted, can blow out at high engine speeds.

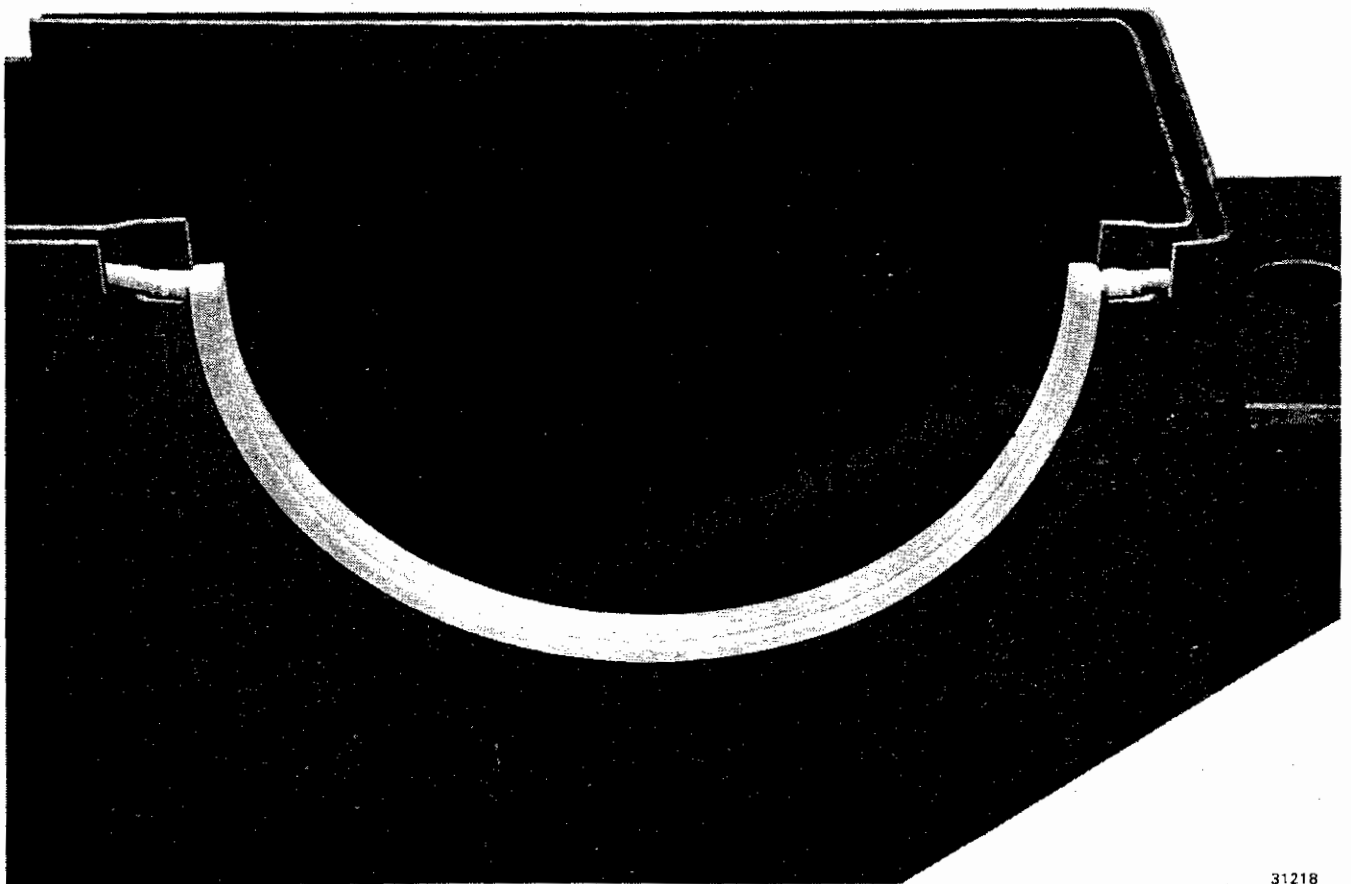
Figure 5. Plastic Gear Case Pinion Seal. (P/ No. 40012790)

A new gear case pinion seal P/No. 40012790, Figure 5, replaces felt seal P/No. 8250270 and fits into gear case channels without any modifications. The new seal is made of a molded plastic material and provides approximately 50% more sealing area than the felt seal.

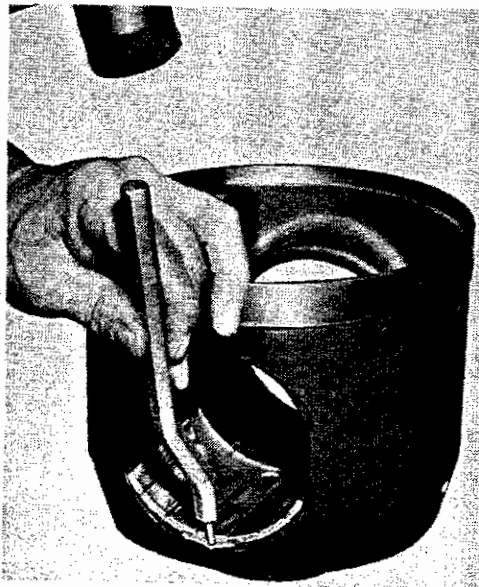
Figure 8. Piston Pin Bearing Insert Installation

On blower-type engines and early model turbo-type engines (those without "rocking" type piston pins), the piston pin insert bearing is installed into the carrier assembly in a broached slot, Figure 8. Tangs at each end of the bearing insert are bent into a counterbore on the carrier to prevent endwise movement. Service tool part number 8311268 is available for the staking of the insert tabs.

When the tabs of the insert are bent or deformed into the counterbore and allowed to make contact with the carrier, zero bearing end play results. This often leads to bearing "lift off" from the carrier bearing bore, resulting in bearing misalignment. Further, this misalignment may result in excessive bearing loading at either end of the bearing insert at the 12 o'clock position.

This procedure is being revised, specifying a 0.005" minimum gap after staking between the tab and carrier seating surface, along with a 0.015" maximum bearing end play. This revised installation procedure should result in positive bearing retention without bearing misalignment, with minimal bearing movement.
