1.0 Introduction

NDNP TECHNOLOGY DIFFUSION ACTIVITY # 27	  Welding Technology Institute of Australia ABN 69 003 696 526 NATIONAL DIFFUSION NETWORKS PROJECT TECHNOLOGY QUESTIONNAIRE Rail Group “Aluminothermic Weld Defects”	Document No: 9.4.1
		Revision No: Rev 0
		Page 1 of 2
		Date: 30 may 2005

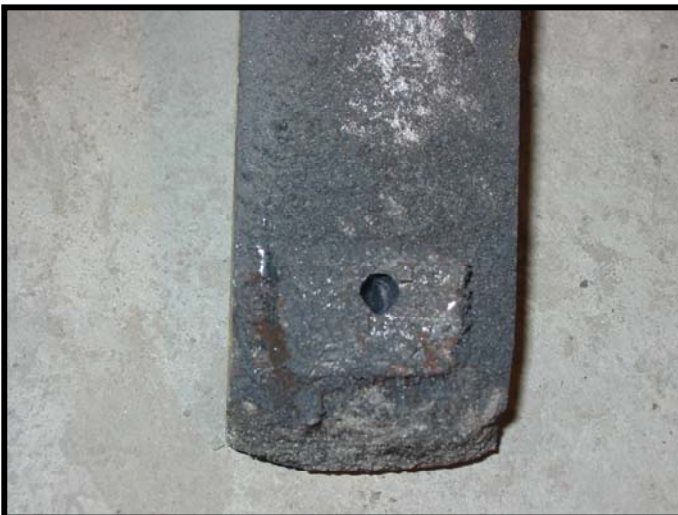
An isolated gas pore in the riser of a weld is known as a “black hole”. The name originated from its characteristic appearance as shown in figure 1

Figure 1. Typical black hole

Black holes have been a major cause for rejection of welds, however there are very few recorded cases of failure initiating from a black hole as the isolated hole is generally fairly shallow and rounded. The defect is caused by gas passing through the weld during solidification. Gas source is from steam from the sealing material under the rail foot. Using narrower than normal weld widths increases risk of getting black holes

To minimise the occurrence of black holes:

- Use a railhead gap > 24 mm, adjusting the weld gap if required;
- Ensure that the luting material is not too wet;
- Observe all checks and procedures to control porosity;
- Ensure that preheating is performed correctly.

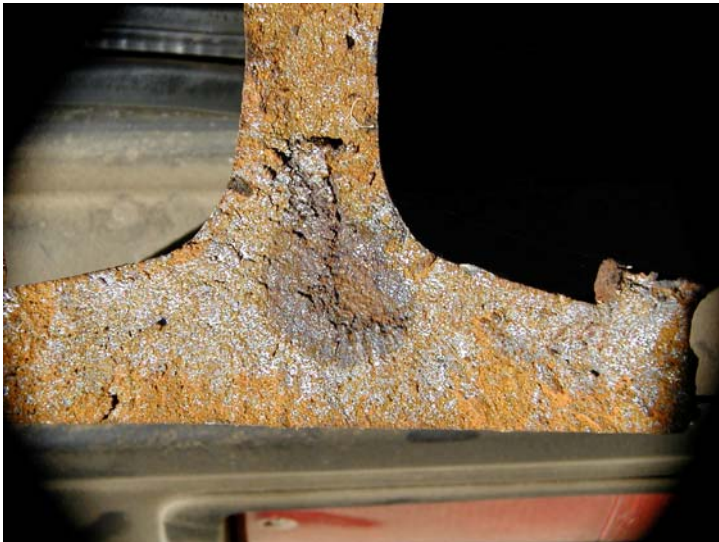
Weld shrinkage or tearing are the same type of defect and generally occurs in the weld foot area as this is the last portion of the weld to solidify as shown in figure 2

Figure 2 Weld shrinkage/tearing

The causes of shrinkage /tearing are due to one or more of the following:

- Insufficient pre heat prior to welding;
- Slip on the tensor jaws;
- Not using tensors or poor set up of the tensors;
- Other work on track causing undue stresses on cooling welds;
- Change in temperature can cause stress on solidifying welds;
- Unclamping of the aluminothermic weld before solidification is complete;
- Passing of traffic while the weld is still too hot.

The weld should be allowed to cool down to below 350°C to allow it to develop sufficient strength before any loads are applied. Hot tensile tests have shown that approximately 80 % of the strength is developed at 350°C.

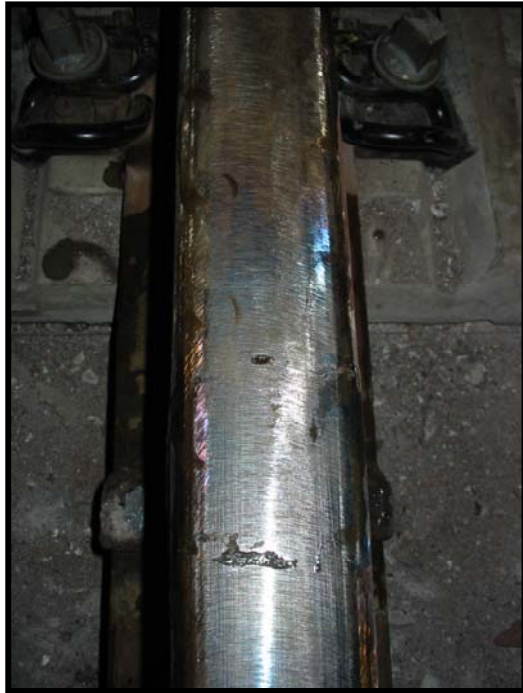
Sand burns occur on the rail surface where luting sand has come in contact with the preheating flame or the pouring steel. The sand is heated to temperature where vitrification of the luting material takes place and marks are burned into the surface of the rail. These defects are normally removed during the grinding operation. Figure 3 shows sand burns remaining after the weld has been ground. In some cases repair welding may be required

Figure 3 Sand burns on ground rail surface

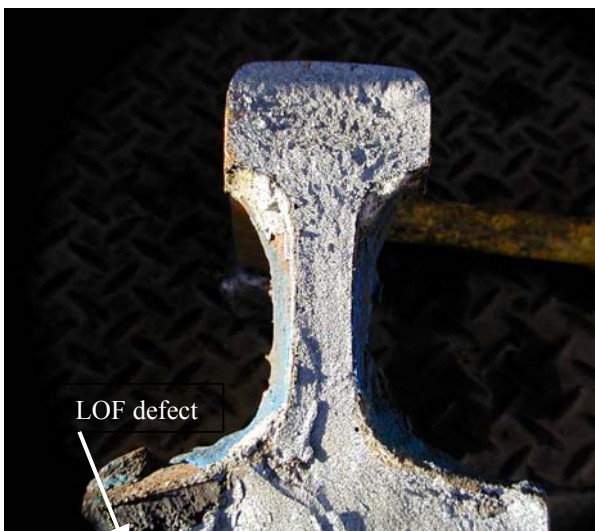
Lack of fusion occurs when the weld fails to fuse into one side or part of the rail as shown in figure 4

Figure 4 Lack of fusion in the rail foot

Lack of fusion defects can result from any one or a combination of the following causes:

- Mould misalignment;
- Cold pour or late pour;
- Inadequate preheat of the joint;
- Poor burner alignment causing uneven preheating of the two rail ends;
- Incorrect gas pressures on the pre heater;
- Incorrect weld gap;
- Incorrect portion size for the size of rail;
- Incorrect mould size being used on the joint.

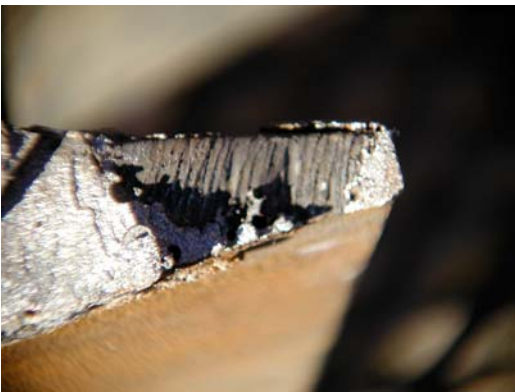
Mould misalignment can cause the weld to not fuse in one or more areas of the rail and figure 5 shows an area where the rail foot has not been incorporated into the weld (the original flame cut surface can still be seen)

Figure 5. Total lack of fusion at rail foot due to mould misalignment

Mould misalignment is due to poor set up, location and fitting of the moulds on the joint. It is essential that the moulds are aligned vertically and are centered on the weld centre line.

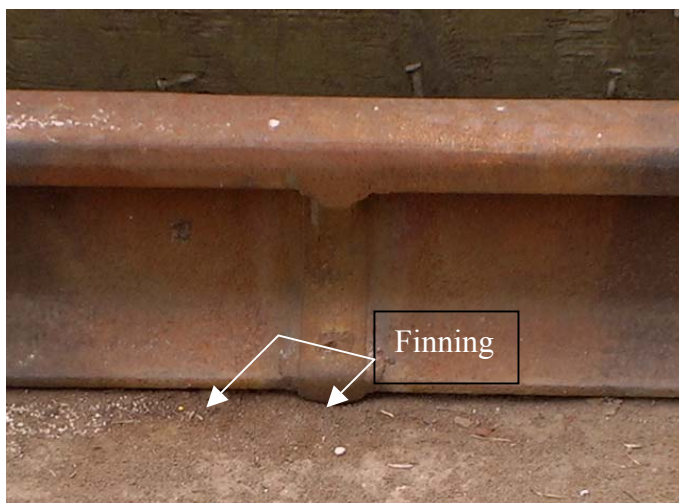
Flashing or finning of aluminothermic welds is where molten metal flows between the mould and the rail and forms a fin or flash as shown in figure 6. It is often not considered as a serious defect, however latest experience has shown that particularly on heavy haul track with high axle loads, a large number of rapid failures have resulted from these defects.

Figure 6. Flashing/finning at the weld edges on the rail foot

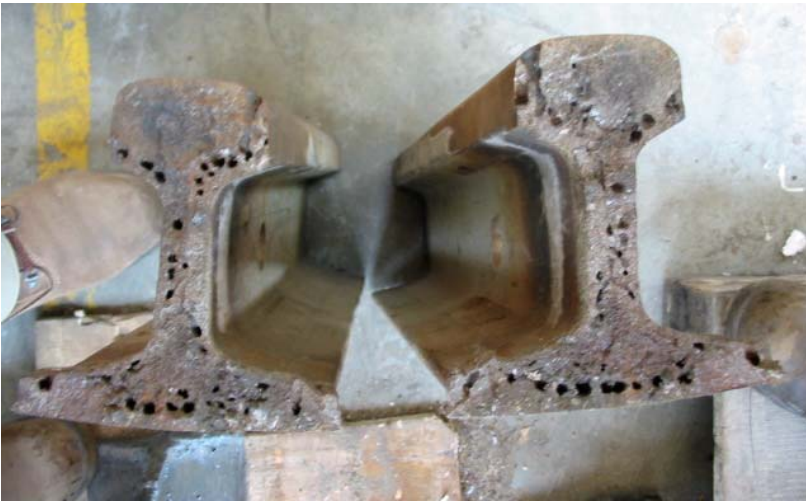
Porosity is mainly located within the weld and is often not visible on the outer surface of the weld. Particularly when a large number of pores are present (as shown in figure 7), the strength of the weld can be significantly reduced.

Figure 7. Gross porosity in the weld

Porosity in aluminothermic welds is caused by any one or more of the following factors:

- Inadequate or no preheating of the crucible in multi use crucibles;
- Wet luting material;
- Insufficient preheat of the joint;
- Wrong portion size for the rail size;
- Wet or contaminated moulds;
- Welding in the rain.
