M AINTENANCE I NSTRUCTION

MAGNAFLUX INSPECTION OF ENGINE COMPONENTS

* THIS BULLETIN SUPERSEDES ALL ISSUES OF MAINTENANCE INSTRUCTIONS 2125, 2126, 2127, 2128, 2129, 2130 AND 2132.

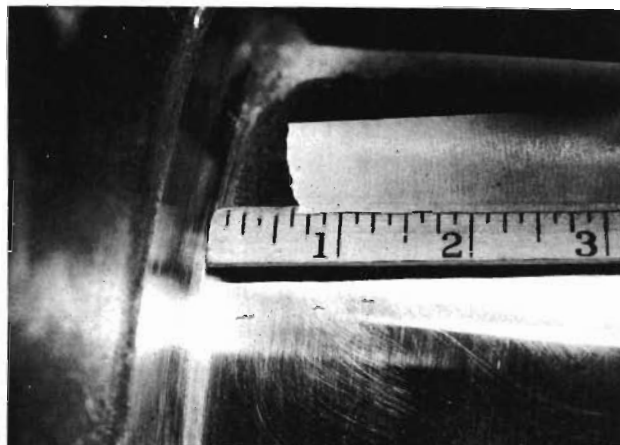
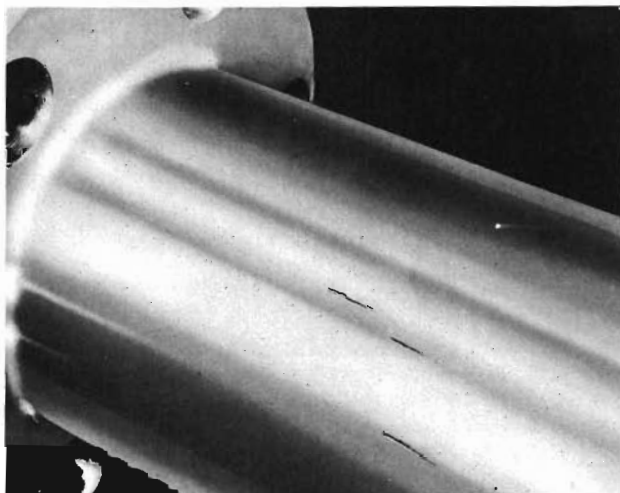
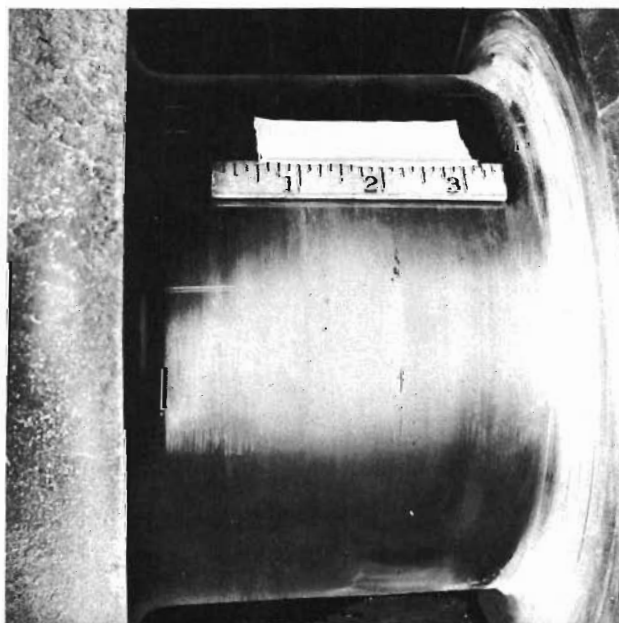
Fig. 2 - Nonmetallic Inclusions

- a. Nonmetallic Inclusions: These are shown in Figs. 2a, b and c. All steels contain varying quantities of nonmetallic materials which may appear as magnaflux indications. Those shown in Fig. 2c are confined to welded shafts. They are oxide deposits which resulted in incomplete fusion during the welding process. The practice in the past was to remove the inclusion in its entirety by "dimpling." Present practice is to flat the sharp edges to prevent bearing scraping but not necessarily remove all of the inclusion. Inclusions have in the past been highly overrated as causes for failures. In our experience we have never been able to definitely correlate a crankshaft failure with inclusions. Unless very definite evidence of fatigue progression from one of these nonmetallic inclusions is found, it may generally be considered that the crankshaft has been

qualified by its service to date of inspection.

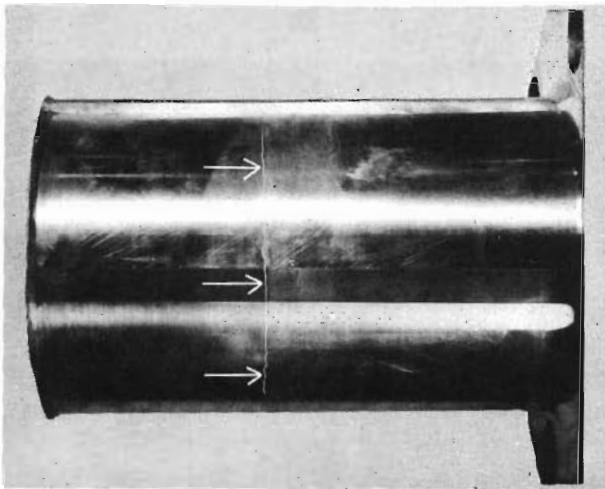
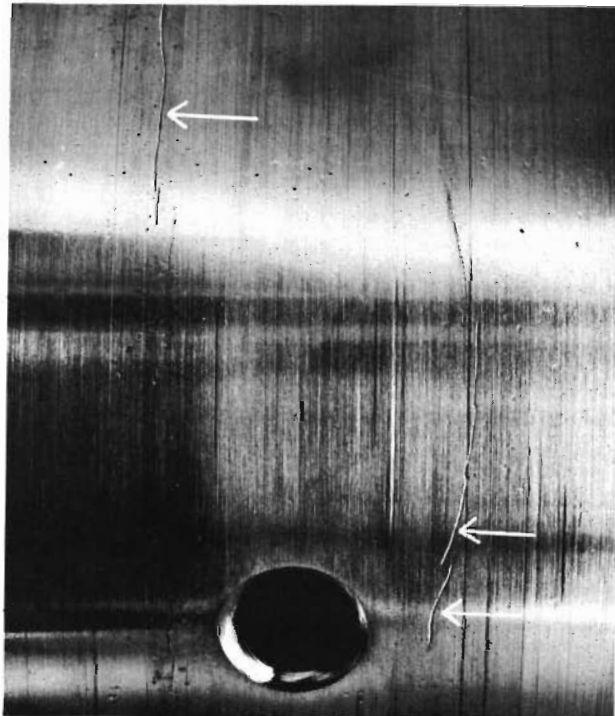
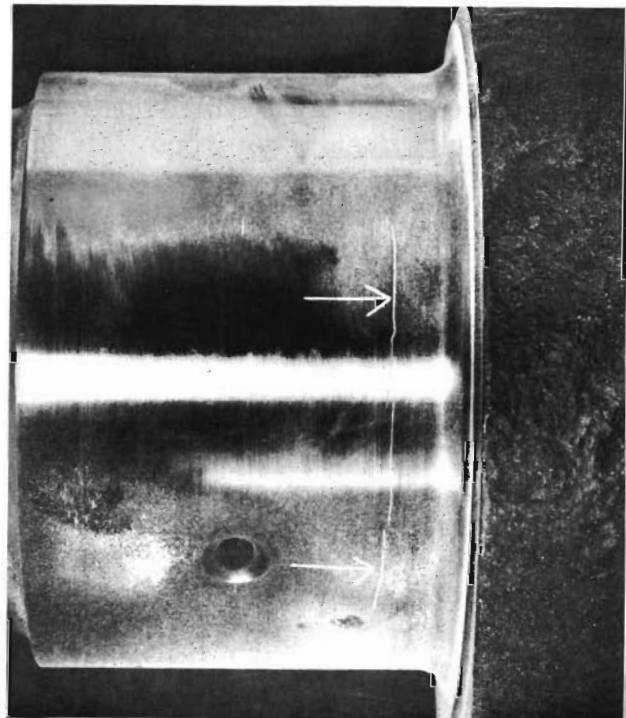
Fig. 3 - Hardening Or "Tocco" Checks

- b. Hardening or "Tocco" Checks: Figs. 3a, b and c. Hardening or "Tocco" checks sometimes develop in the induction hardening process on the journals. They are very fine hairline cracks found at the edge of the hardened zone circumferentially to the axis of the shaft. Occasionally, they are found on the

crankpin journals but more often on the mains, especially at the edge of the hardened area near the center of the last or double main journal. They are never in the fillets but approximately 5/8" from the thrust wall. On welded shafts this condition exists also at the edges of the welds as shown in Fig. 3b. These "Tocco" checks have definitely been established as harmless insofar as the life of the crankshaft is concerned.

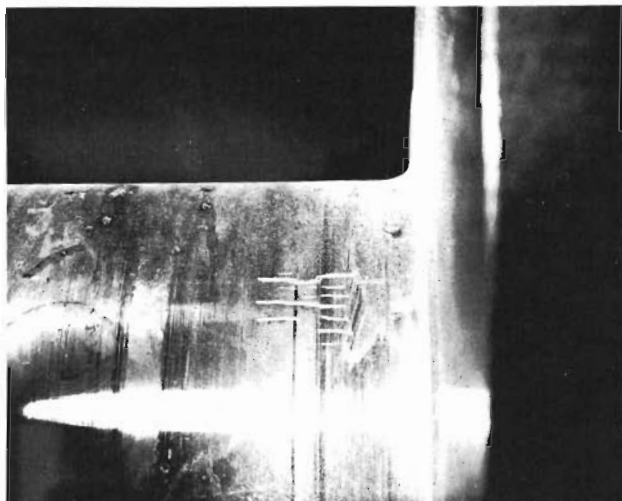
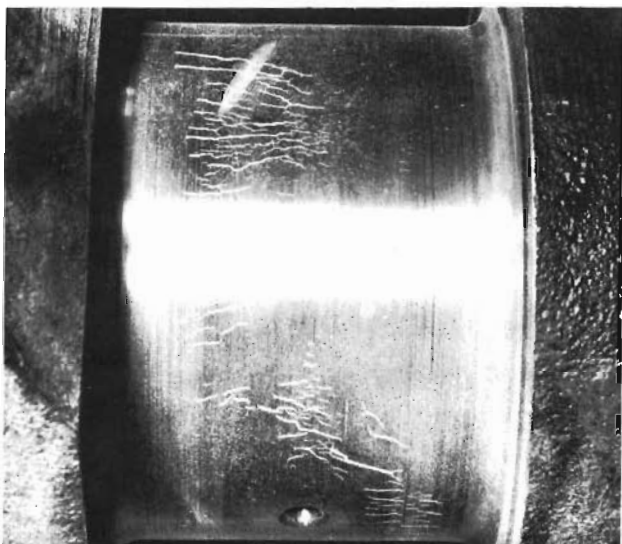
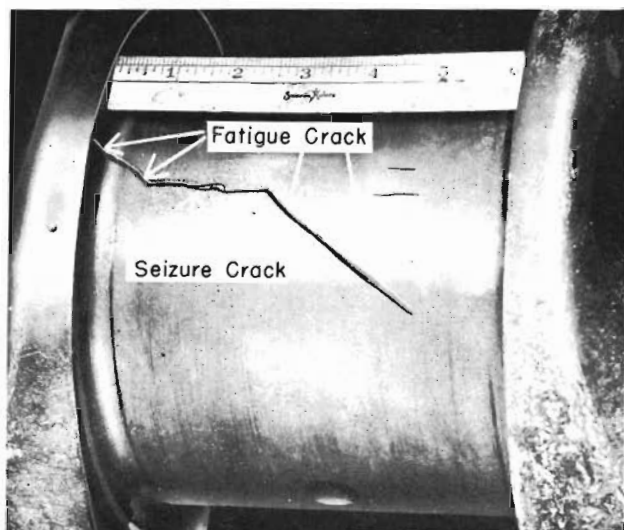
Fig. 4 - Seizure Cracks

- c. Seizure Cracks: Figs. 4a, b and c. When an oil failure results in bearing seizure, quite often there are longitudinal or circumferential cracks sometimes accompanied by a network pattern of cracks. This is usually associated with discoloration and other evidences of bearing seizure. The circumferential heat cracks are often deep, however, when using wet magnaflux medium, one must differentiate between actual heat checks and

indications developed due to scoring. Discoloration is usually the distinguishing evidence in this case. When still in doubt, observation with a magnifying glass is often helpful. Any crankshaft which shows indications of heat checks resulting from bearing seizure should not be placed back in service. Fig. 4c is a photograph of a journal which shows a fatigue crack starting from a heat check.

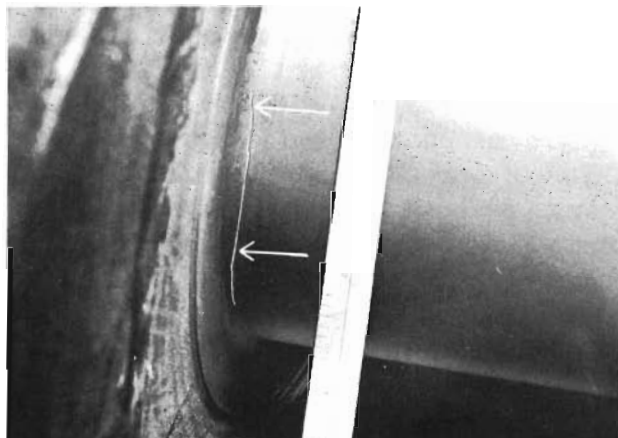
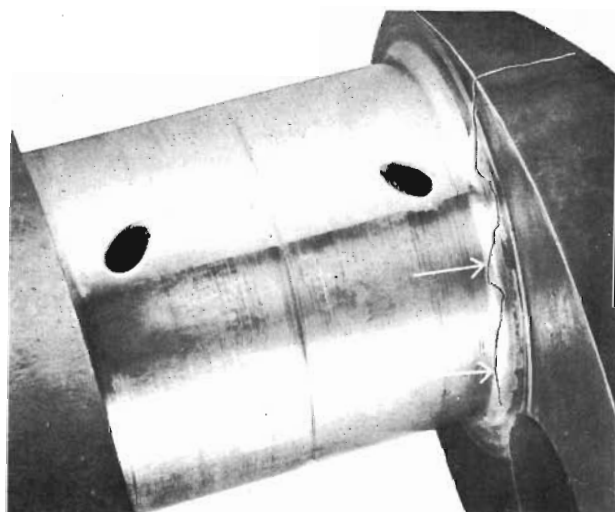
Fig. 5 - Fatigue Cracks

d. Fatigue Cracks: Figs. 5a and b. Occasionally, due to the lack of proper bearing support, the crankshaft is subjected to

excessive bending stresses. Fatigue failures originating due to this overstressing generally occur in the center of the fillets, run circumferentially for several inches in the fillet and then proceed through the cheek to ultimate failure. Circumferential indications in the center of the fillets should be viewed with extreme suspicion since it is probable that they represent the start of fatigue failure of the shaft.

A crankshaft cannot be salvaged if there is a crack over 1" long and more than 1/16" deep in the surface of either a main bearing or crankpin journal or any journal fillet. The depth of the crack may be determined by trial grinding with a high speed machine fitted with a fine conical stone. If, after this examination, it appears that a shaft may be salvaged, it should be returned for machine grinding and rebalancing.

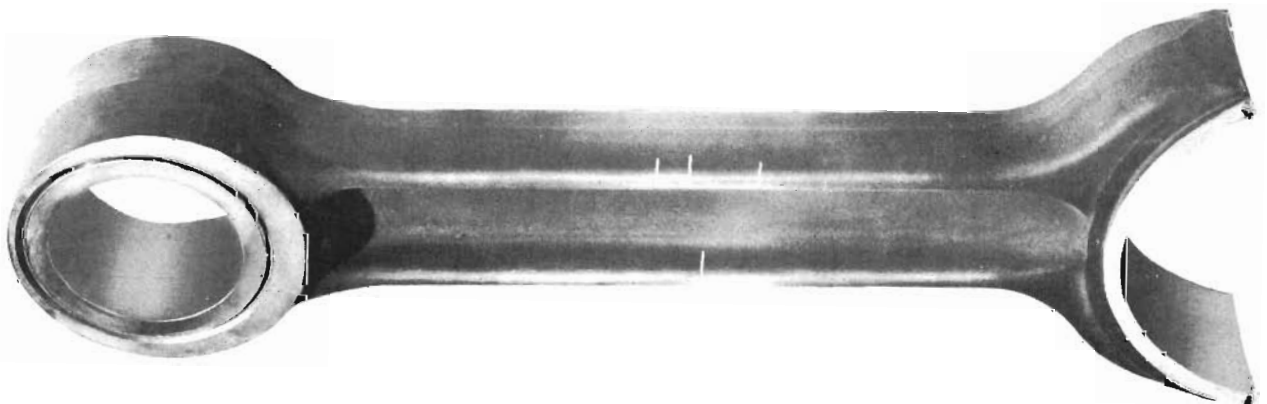
Fig. 9 - Connecting Rod Defect Indications

Fig. 9 shows magnaflux indications of transverse defects in the rod

flanges, using gray magnaflux powder. Any defects in this direction and location reject the blade or fork rod, since they usually result in failure.

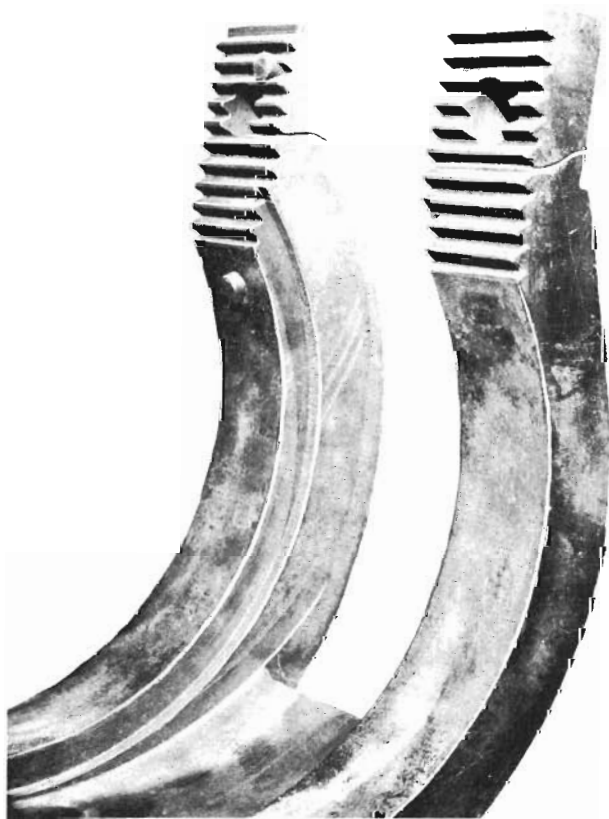
Fig. 10 - Example Of Fatigue Cracks

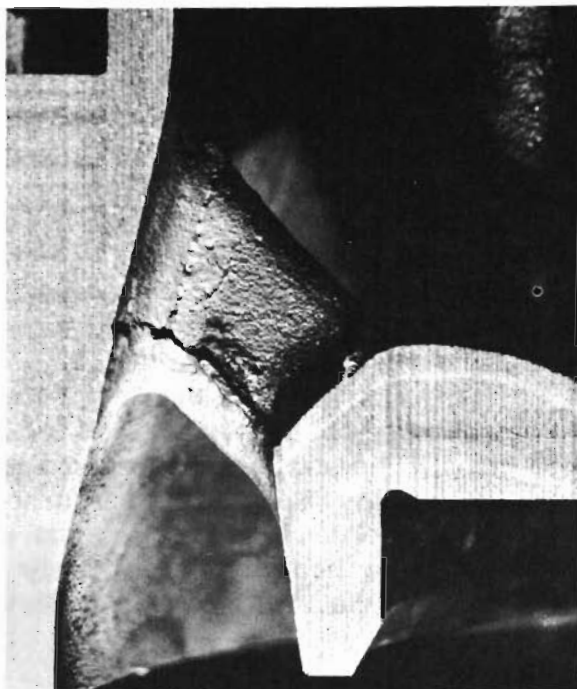
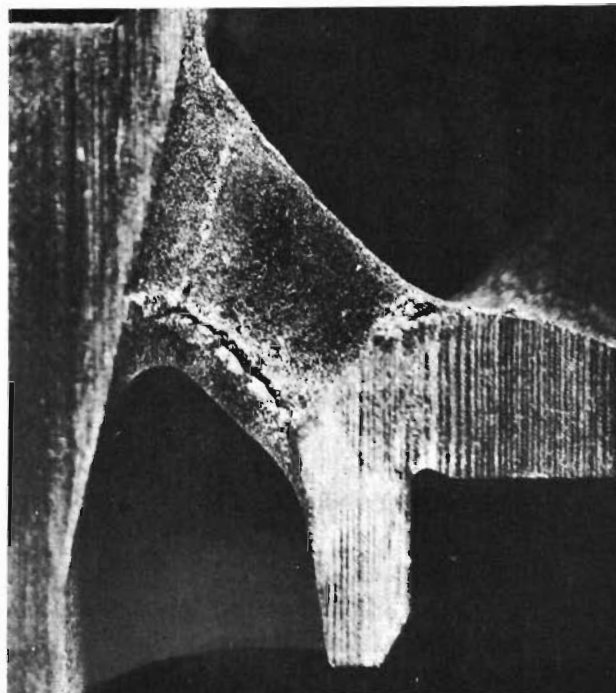
Fig. 13 - Tie Rib Core Parting Line

Cracked platform tie ribs reject the piston. Generally, indications on the tie ribs are due to casting

characteristics, and are not true indications of cracks. Fig. 13 shows the tie rib core parting line with normal lighting. The same area taken with 'black light' is also shown. Fracturing the casting through this parting line reveals no defect and shows that false indications are prevalent in this area. If doubt remains as to the interpretation of the indications, typical samples should be sectioned through the questionable area.

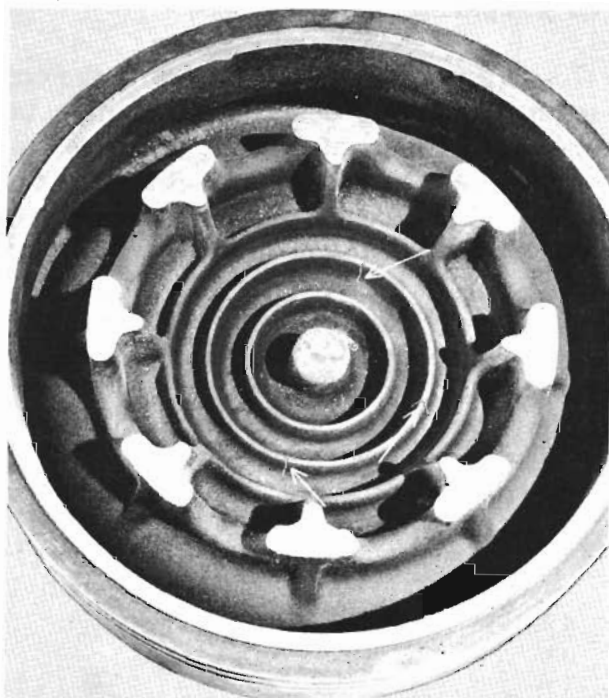
Fig. 14 shows indications on the piston cooling fins. A certain percentage of pistons in the field are known to have cracked cooling fins. They may be found on all the fins, in-line or staggered. Pistons showing cooling fin cracks are acceptable for further service, except those pistons which have been damaged due to some related part failure, as for example a valve, since the cracks induced by the

failure have not been subjected to the thermal stress relieving operations which our production pistons undergo.

Fig. 14 - Cooling Fin Magnaflex Indication

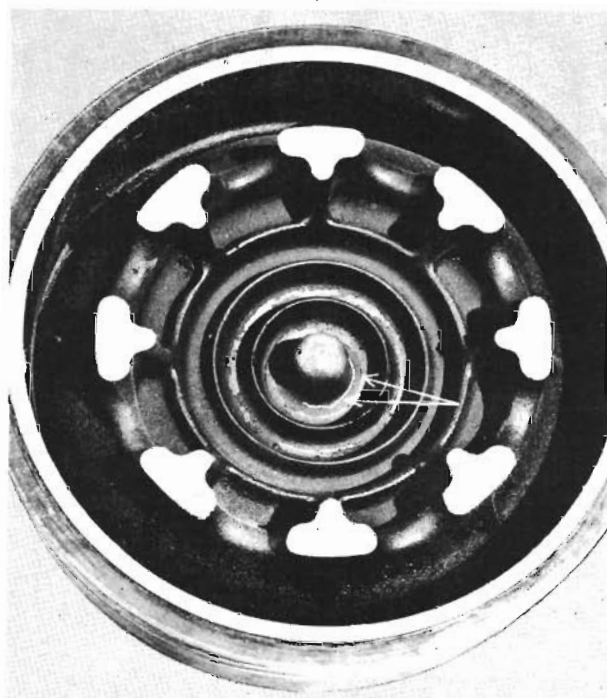
Fig. 15 shows indications in this area. Cracks encircling the puller

Fig. 15 - Defect Around Puller Hole Boss

hole boss or similarly concentric cracks between the cooling fins, reject the piston.

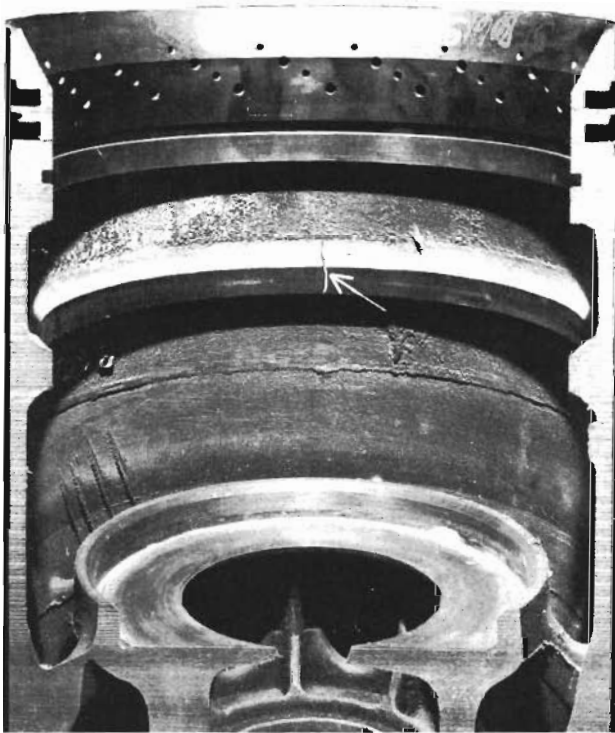
Fig. 16 shows an indication in the pin ring. Pin ring cracks are acceptable, provided they do not extend into the piston wall. Pin ring cracks extending into the piston wall are cause for rejection of the piston.

Fig. 16 - Pin Ring Magnaflux Indication

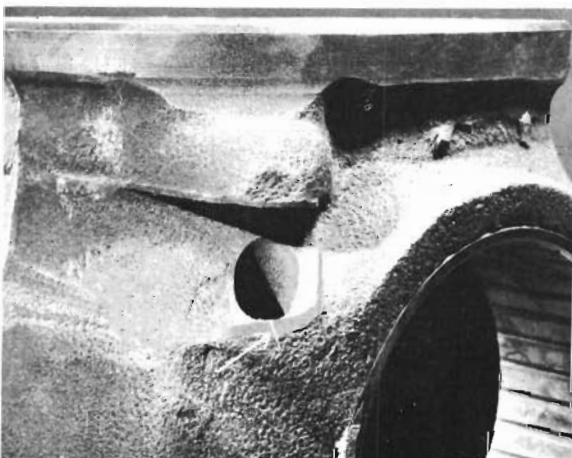
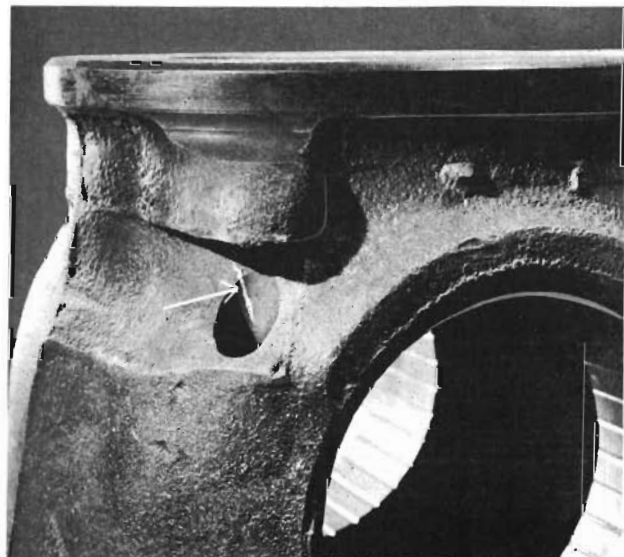
Fig. 21 - Oil Hole Defect Indication

Fig. 22 - Oil Hole Defect Indication (Inside)

Usually fatigue cracks have their origin in oil holes of the carrier. Figs. 21 and 22 are

photographs of the beginning of failures. Fig. 23 shows an advanced stage of failure where the fatigue crack has progressed to piston pin bore. Carriers which reveal magnaflux indications in these locations should be rejected.

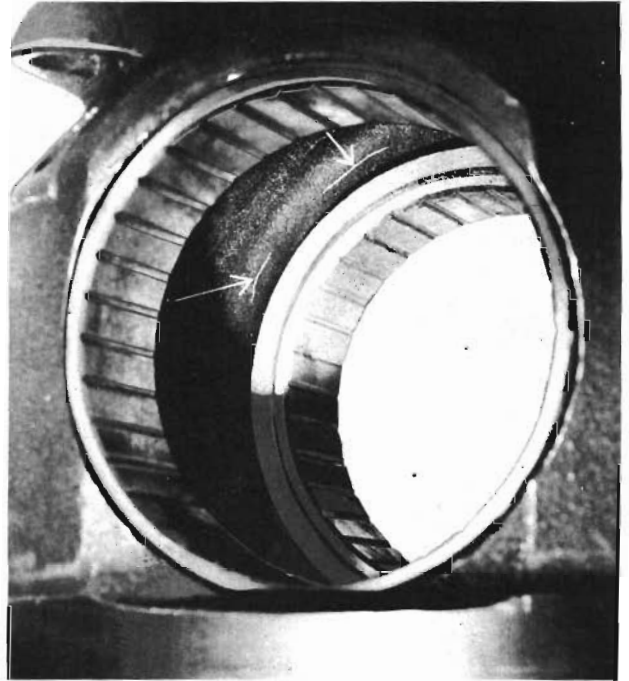
Certain defects may be revealed at overhaul inspections which are due to abnormal conditions in the foundry at the time the parts are cast. The most common of these are shrink cracks surrounding the piston bore boss as shown in Fig. 24. Similar indications may also appear in the crown recess. Unless definite progression of these can be found, they should be accepted. In general, indications found on the lower half of the carrier are harmless.

Fig. 24 - Magnaflux Indication Inside Of Pin Boss

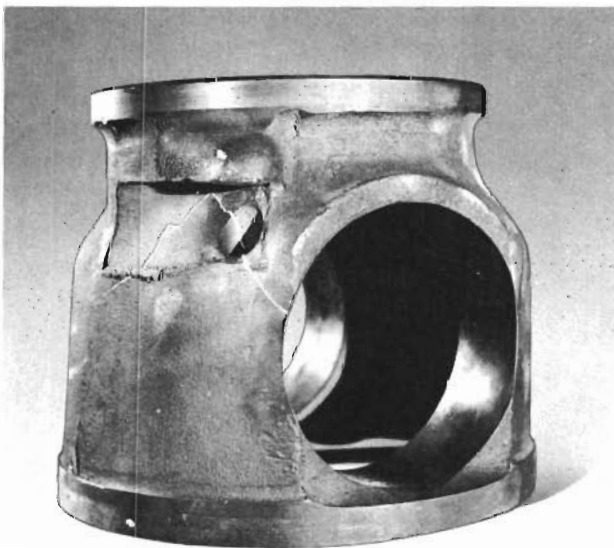
Fig. 23 - Defect Progression From Oil Hole

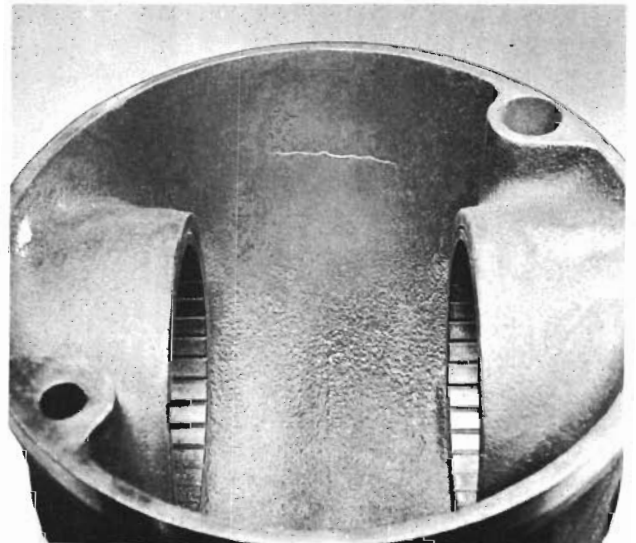
cracks will be found in the bottom wall. These are usually through the wall, and the part should be rejected. The indication shown on Fig. 25 is one type which may be attributed to mishandling and is cause for rejection of the part. Often, cracks will be vertical in direction.

Fig. 25 - Defect Indication Bottom Wall

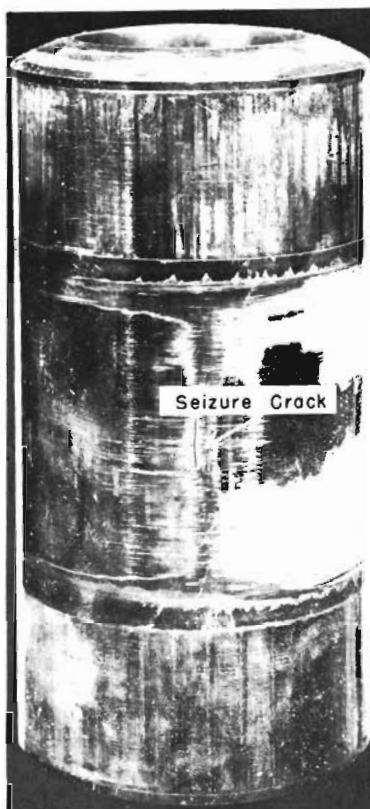
Failure of this type of piston pin is nearly always a result of overheating. Fatigue cracks originate from heat checks on the surface. These checks are longitudinal in direction in the center section of the pin, Fig. 28. As the fatigue cracks progress, they tend to become circumferential at the witness band (the area between the rod bushing and the carrier bushing), Fig. 29. The surface of overheated pins is sometimes straw to blueblack in color. At other times, however, no discoloration is present due to subsequent polishing action in the engine.

Fig. 28 - Piston Pin
Magnaflux Defect
Indication

Magnaflux indications of fatigue cracks or heat checks are cause for rejection of the pins. Indications of nonmetallic inclusions are acceptable.

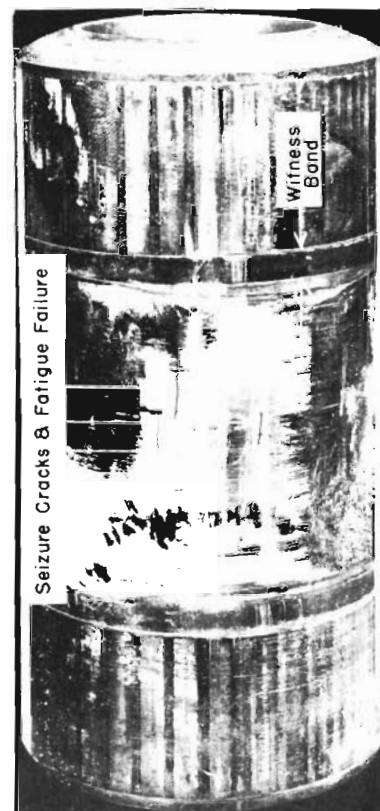
Fig. 29 - Progression
Of Magnaflux Defect
Indications

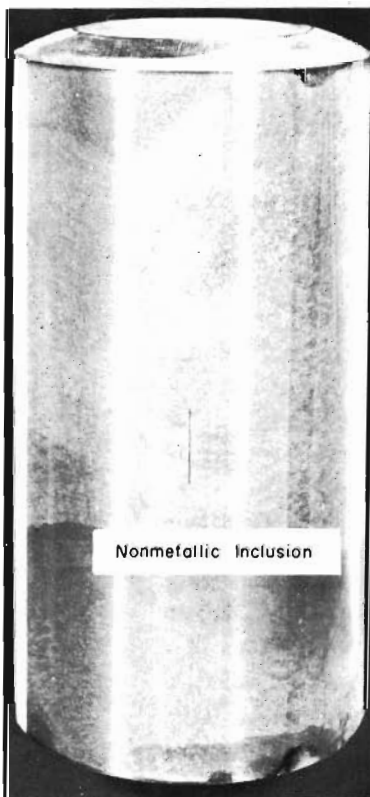
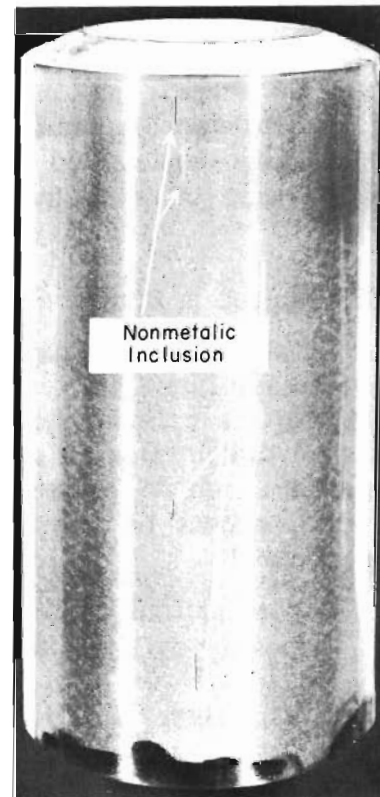
Nonmetallic inclusions, the impurities contained in various amounts in all steels, are also in a general longitudinal direction. It is therefore often difficult to differentiate between nonmetallic inclusions and fatigue cracks when high current densities are employed. This is especially true in the absence of discoloration. The indications of inclusions shown in Fig. 30 were produced with high amperages on new pins.

Fig. 30 - Nonmetallic Inclusion Indications

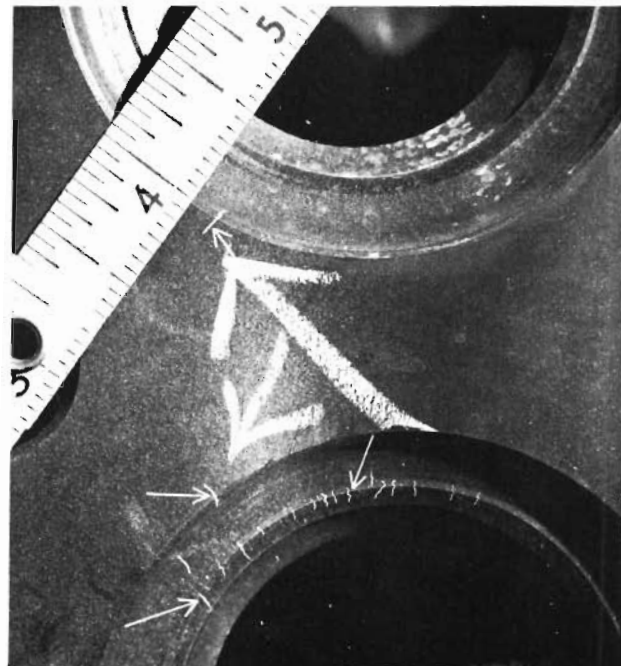
1. Indications of cracks on the bottom of the cylinder head around the injector well or valve seat as shown in Figs. 31 and 32 are cause for rejection of the cylinder head.
2. Indications of cracks on inside of the head, such as in the exhaust

Fig. 31 - Magnaflux Indication Of Cracks On Valve Face

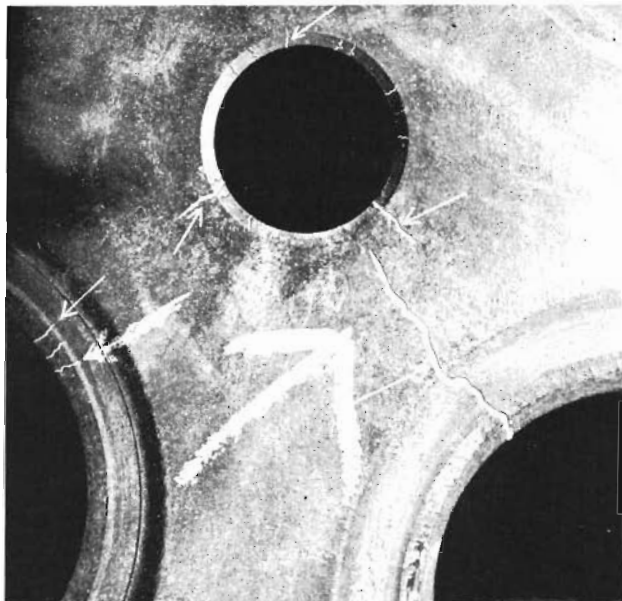
Fig. 32 - Magnaflux Indications At Injector Well And Valve Faces

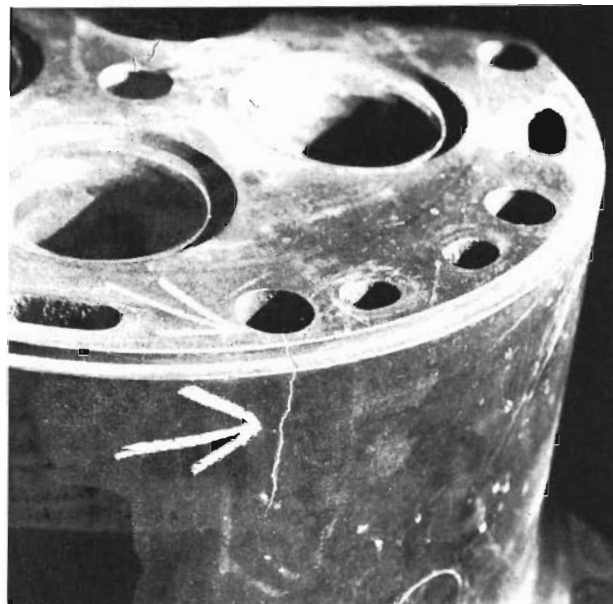
3. Heads disclosing stud hole cracks in the outer wall as shown in Fig. 33 are usable, unless the crack exceeds 4" in length.

Fig. 33 - Magnaflux Indication At Stud Hole Of Cylinder Head
