M AINTENANCE I NSTRUCTION

MAGNAFLUX INSPECTION OF ENGINE COMPONENTS

* THIS BULLETIN SUPERSEDES ALL ISSUES OF MAINTENANCE INSTRUCTIONS 2125, 2126, 2127, 2128, 2129, 2130 AND 2132.

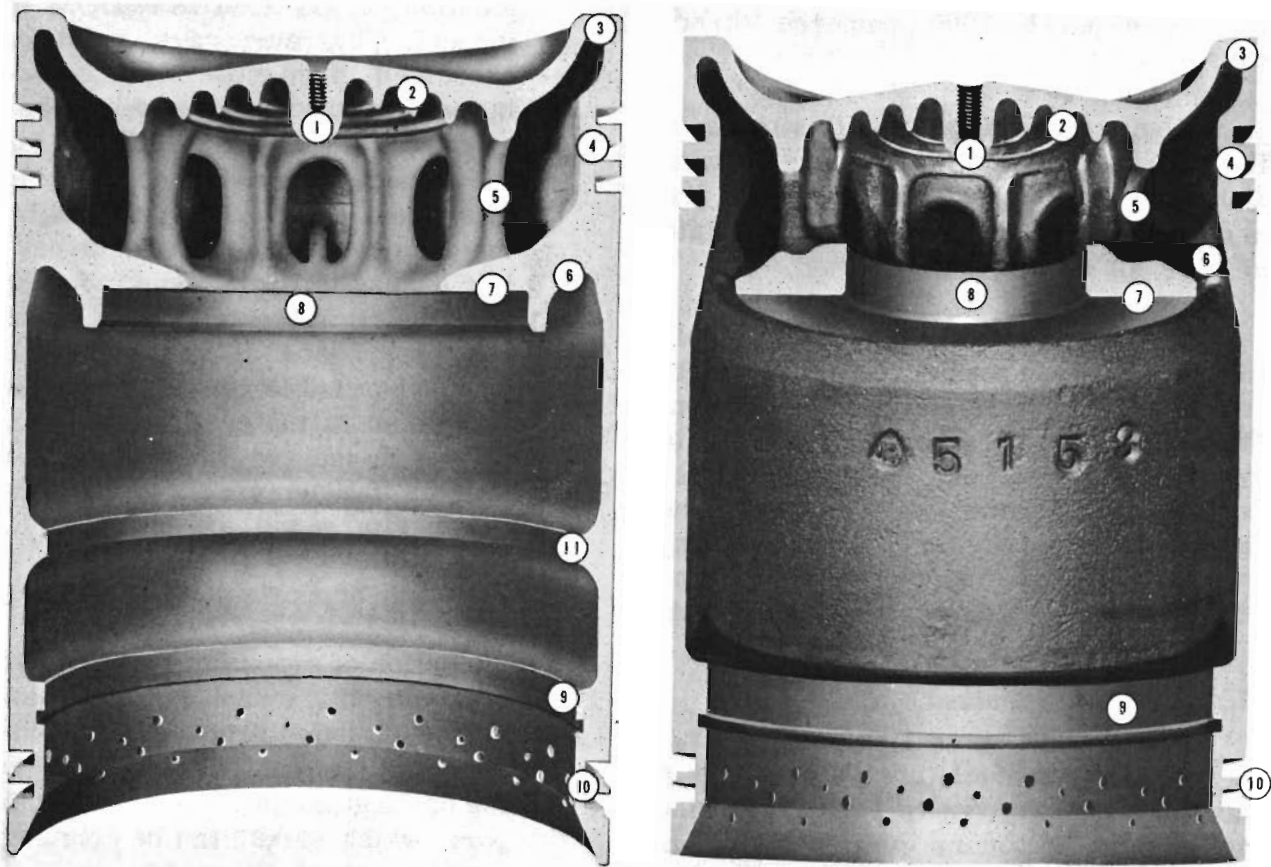
Fig. 12 - Piston Nomenclature

Fatigue failures of the crown have their origin in the recess under the crown rim. See Fig. 12 for

location. This area is difficult to inspect. Extreme care must be exercised in interpreting accumulations of powder or magnaglo because of the natural tendency for the inspection material to settle in this area. When using magnaglo, the piston should be tilted to permit excess to drain away from the area being inspected. If a crack has progressed at any extent, it should be visible on the outside of the piston at the crown rim. Heat checks in the crown or "bowl" as well as fatigue cracks under the crown rim reject the piston.

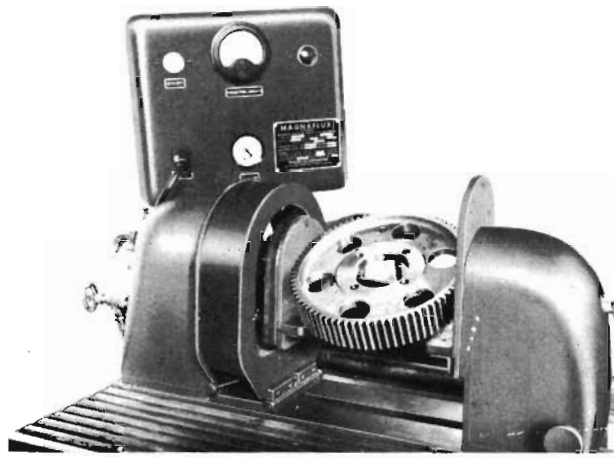
Fig. 35 - Gear Magnaflux Inspection

The purpose of the magnaflux inspection of the gears is to detect fatigue

cracks which may develop in service. Fatigue cracks reject the gear, and they usually occur in the root area of the teeth.
