MODERNIZATION RECOMMENDATION

EMDEC FUEL HOSE CLAMPS

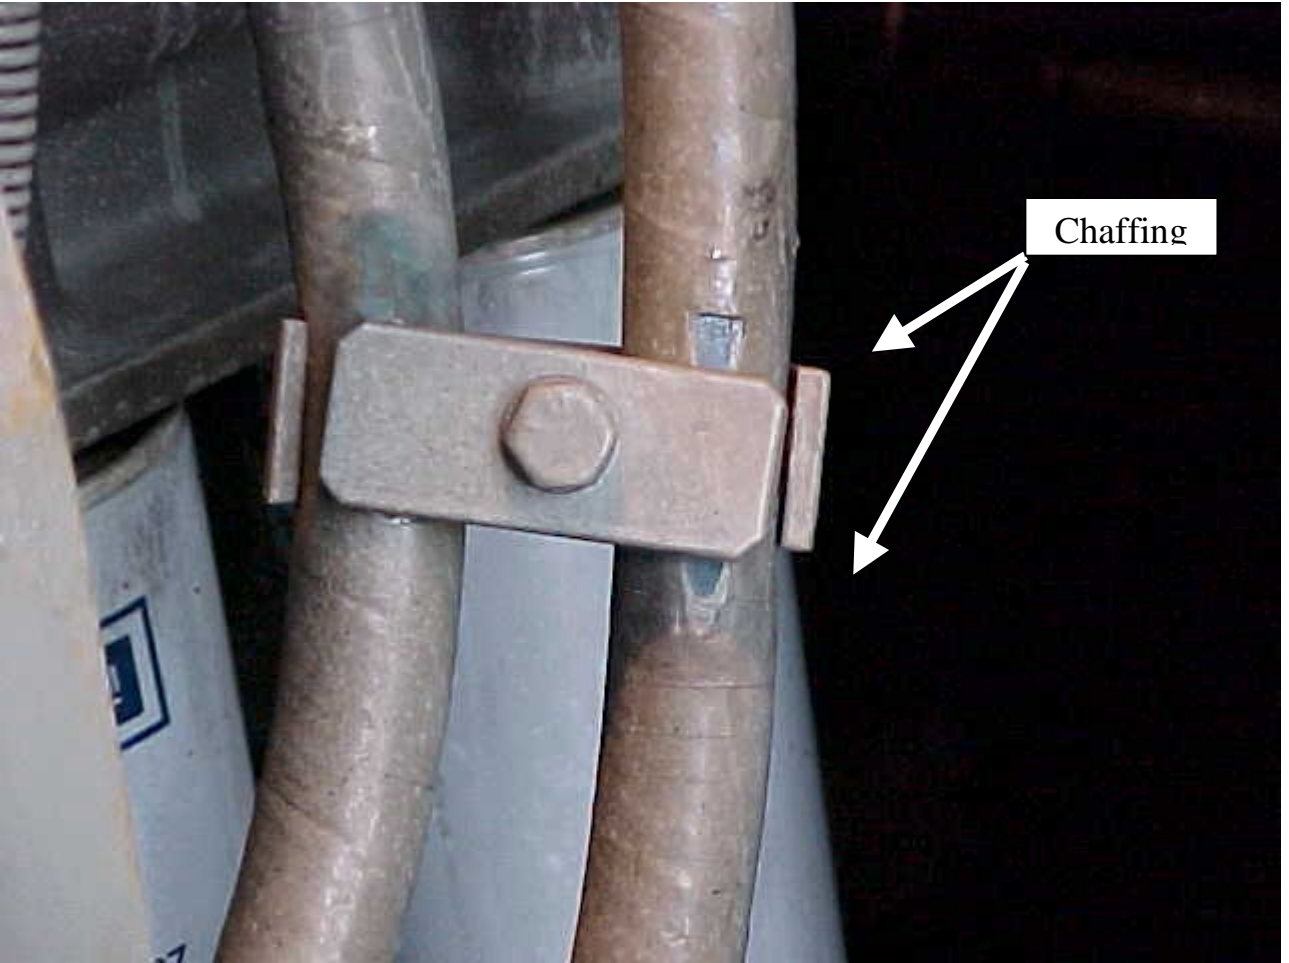
Field reports indicate that side-mounted ECM cooling plate hoses are experiencing chafing damage at the free-floating retaining clamps (see attached photo). This chafing may result in a loss of hose material, broken hose braid wires, and potential fuel leaks over time. The cause of hose chafing is vibration and inherent looseness of metal clamping on solid rubber material.

Use the following criteria for condemning hoses: If the chafed damage has exposed the braided wires, and at least one braid wire is broken, replace the hose.
